# Manhole Inspection Summary

Manhole # S27S\_\_017MH

**Location** Address: **1601 Severn St**

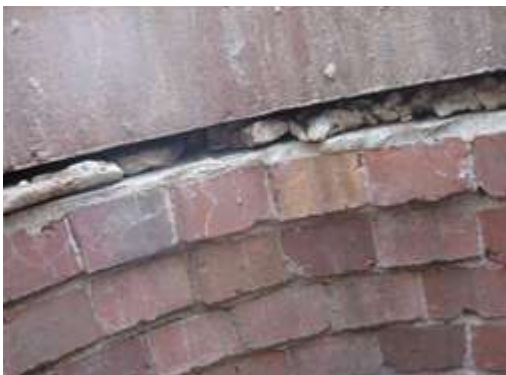
Defect 2

Condition: ☐ Sound ☐ Cracked ☐ Root Intrusion ☐ Loose Brick ☒ **Deteriorated**

Infiltration: ☐ None ☒ **Joint** ☐ Cracks ☐ Mortar ☐ Roots ☐ Wall

missing mortar and bricks at joint of frame and chimney

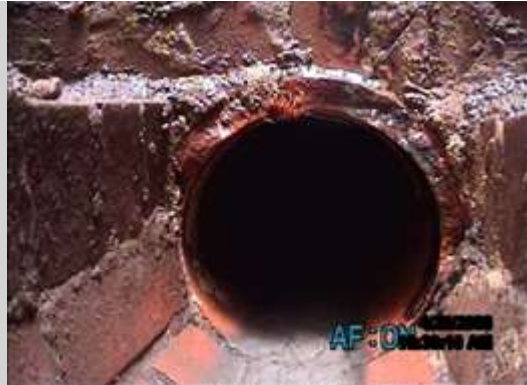
12 O'Clock Outflow

Pipe Height: **8.4** (in.) Rod and Bar (Angled)  
Pipe Material: **Clay** ☐ Pipe Lined  
Invert Depth: **10.67** (ft.) Flow Characteristics: **Slow**  
Deposits: ☒ None ☐ Mud ☐ Sludge ☐ Debris ☐ Grease  
Silt Depth: **0** (in.) Deposits Extent:  
Infiltration: **None** Pipe Seal Cond: **Sound**

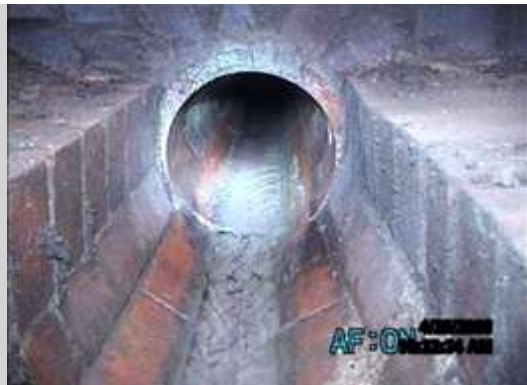
6 O'Clock Inflow

Pipe Height: **8.4** (in.) Rod and Bar (Angled)  
Pipe Material: **Clay** ☐ Pipe Lined  
Invert Depth: **10.56** (ft.) Flow Characteristics: **Slow**  
Deposits: ☒ None ☐ Mud ☐ Sludge ☐ Debris ☐ Grease  
Silt Depth: **0** (in.) Deposits Extent:  
Infiltration: **None** Pipe Seal Cond: **Sound**
